Water Environment Improvements Project Evidence Form

Marden Quarry Water and Wildlife

Summary

Through this project, North Tyneside Council has worked with NWG to deliver access and recreation improvements throughout Marden Quarry Local Nature Reserve improving 1 km of water environment.

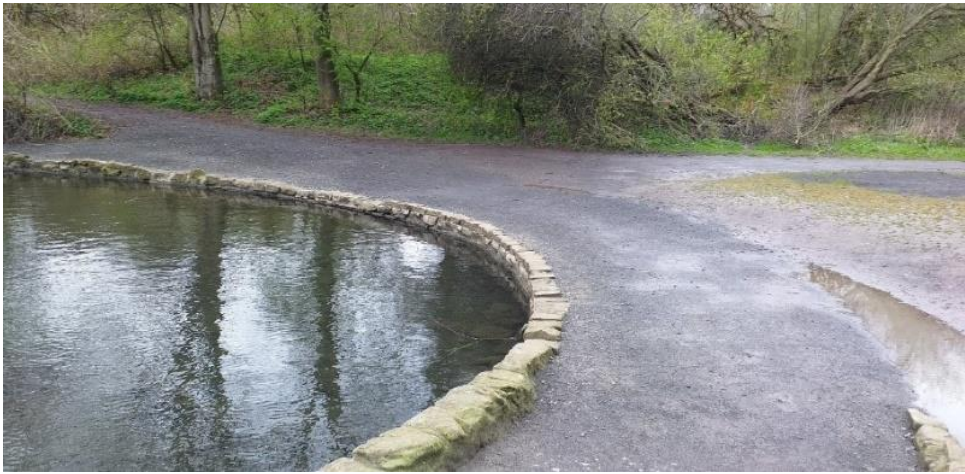
<p>Lakeside access improvements</p>

Outputs	
<ol style="list-style-type: none"> 1. Identified footpath sections have been improved, with areas cambered, raised and resurfaced to allow rain water run-off into the lake, and pot holes filled reducing risk of slips, trips and falls (completed March 2022) 2. Access has been improved to maintain accessibility alongside the lake, with retainer structures and a ramp path created with handrail leading to the dipping platform (completed March 2022) 3. A dipping platform has been installed using recycled plastic (completed July 2023) 4. 2 new bird identification interpretation panels have been designed and installed along the trails to engage the public with local wildlife on site (completed June 2023) 	
Evidence

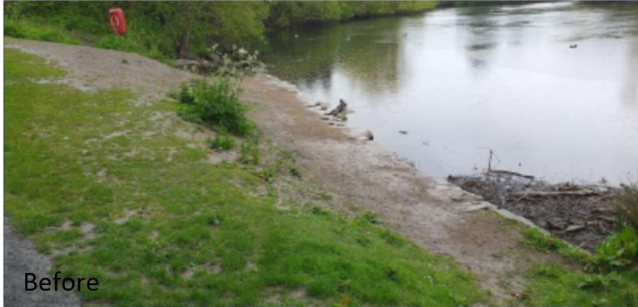
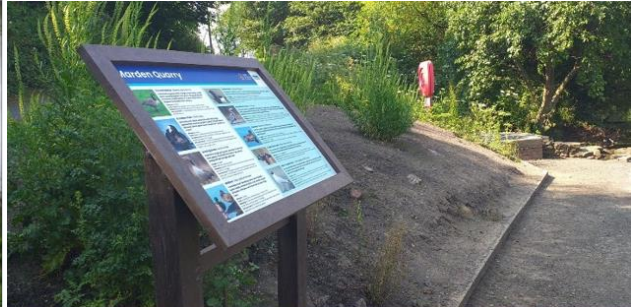
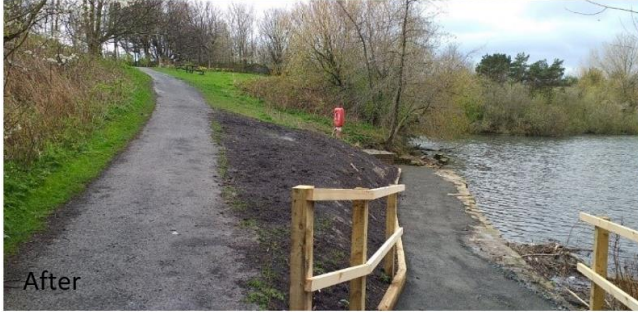
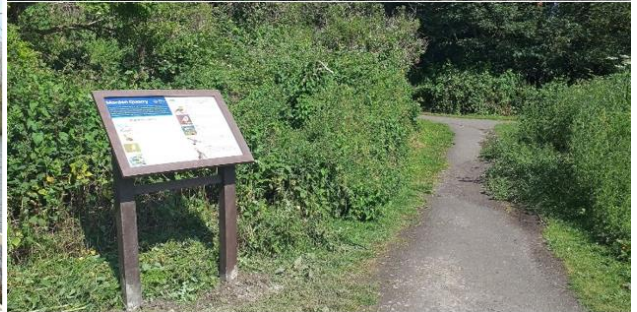
Before and after images of site improvements to lake access and interpretation

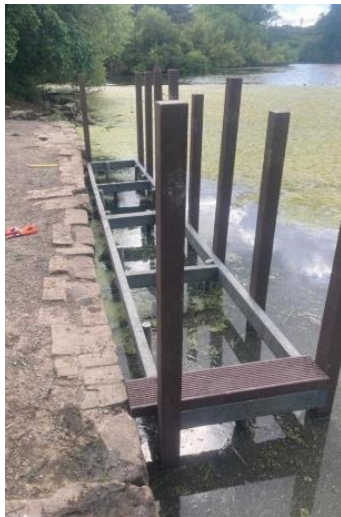
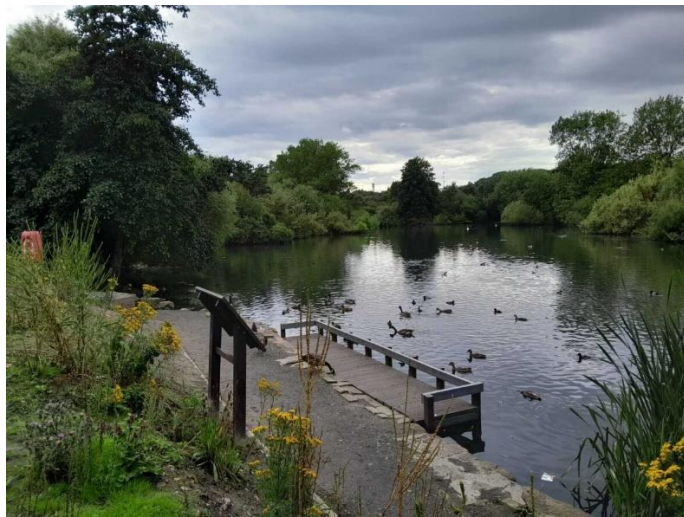
Before and after images of dipping platform

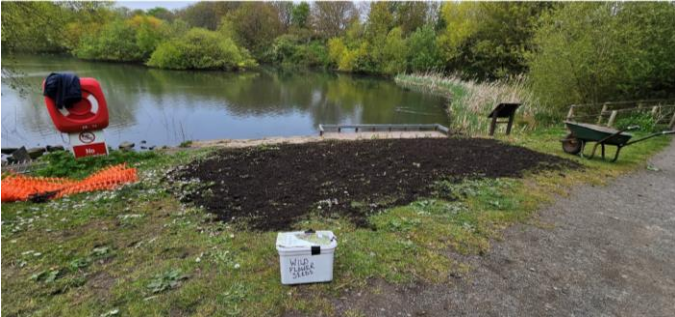
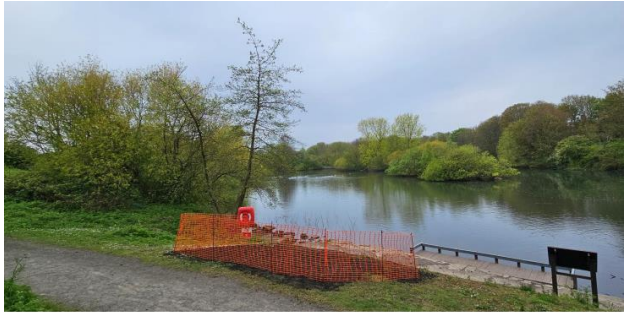
</div> <p style="text-align: center;">Bankside planting of wildflowers and protection during establishment</p> <div style="text-align: center;">

Wildlife & Biodiversity	
Expected Project Outcomes	Benefits
<ol style="list-style-type: none"> Appropriate planting on slopes will provide a better marginal lake habitat for wildfowl (completed April 2024) Aquatic planting will provide valuable spawning habitats for breeding fish (completed April 2024) 	<ul style="list-style-type: none"> ➤ B1: Improves the quantity, quality and connectivity of habitats
Outputs	
<ol style="list-style-type: none"> A wildflower seed mix has been sown along the bankside in the areas where access improvements have taken place. Phragmites australis has been planted around the pond outflow, providing additional vegetation cover for breeding fish and other wetland wildlife. Hand removal of invasive marginal vegetation <i>typha latifolia</i> has also been undertaken 2022/23 to keep the plant under control and allow other marginal species to thrive. 	
Evidence	
<div style="display: flex; justify-content: space-around;">

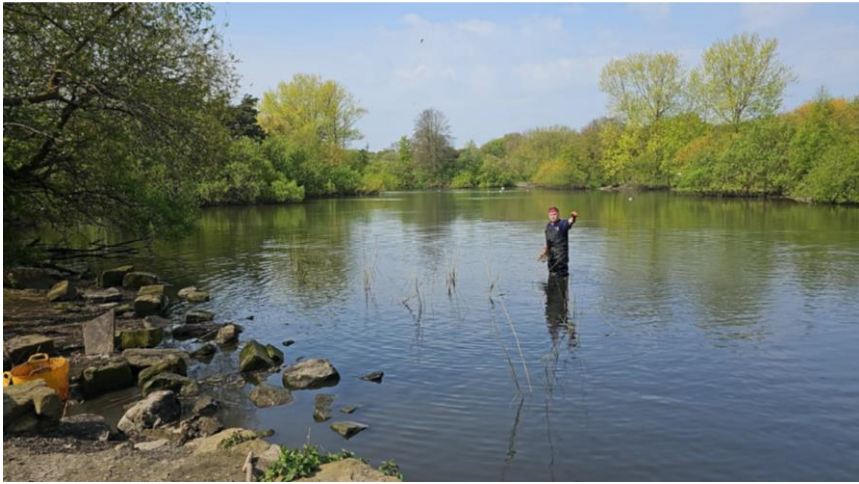
<p>Aquatic planting of phragmites</p> </div>

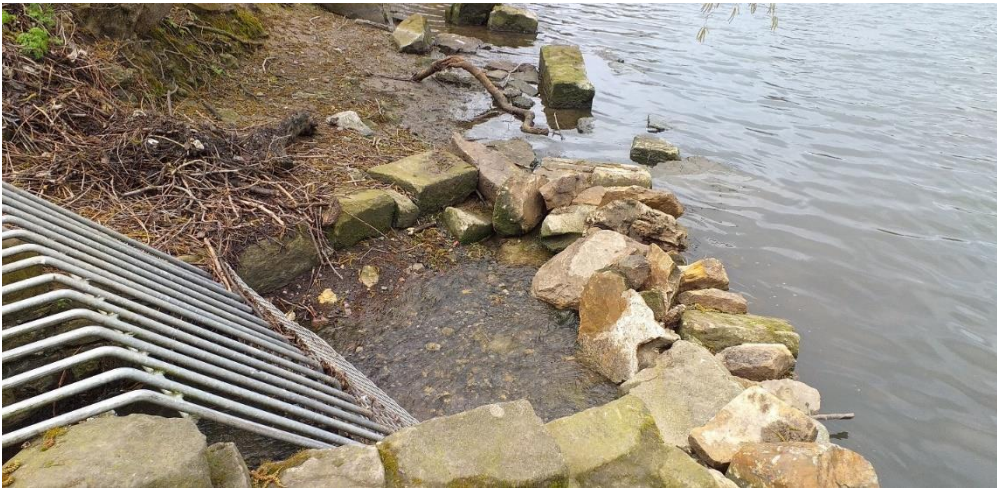
<p>Stone barrier around lake outfall</p>

<ol style="list-style-type: none"> The outfall has been improved by a stone barrier and filtering of potentially blocking material will be assisted by aquatic planting in the lake. No flooding of local properties has been reported or recorded in Autumn Winter 22/23 following the improvement works, and the effectiveness of the solution will continue to be monitored by North Tyneside Council. The improvements to the site and its popularity mean that Marden Quarry was one of eight North Tyneside sites chosen to be awarded a Green Flag from Keep Britain Tidy in 2023. This project has delivered positive interventions which aims- to improve the quality of the lake outfall discharge to Cullercoats, contributing to wider focus on coasts and bathing waters.

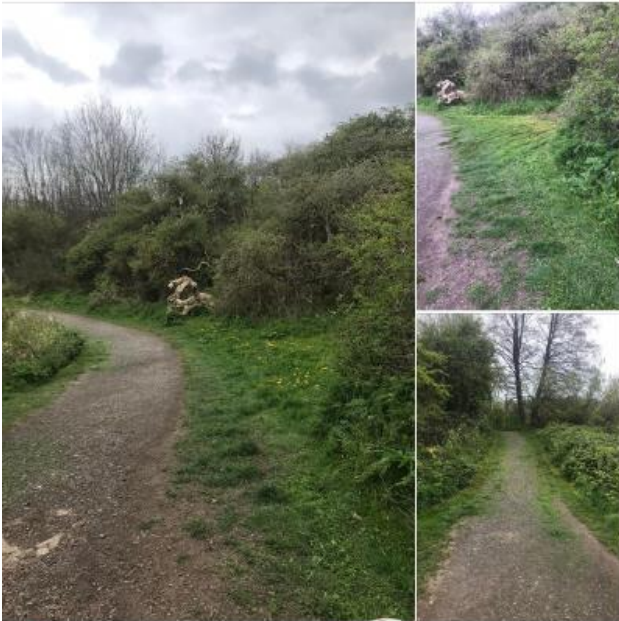
A good day cutting the paths around the lake

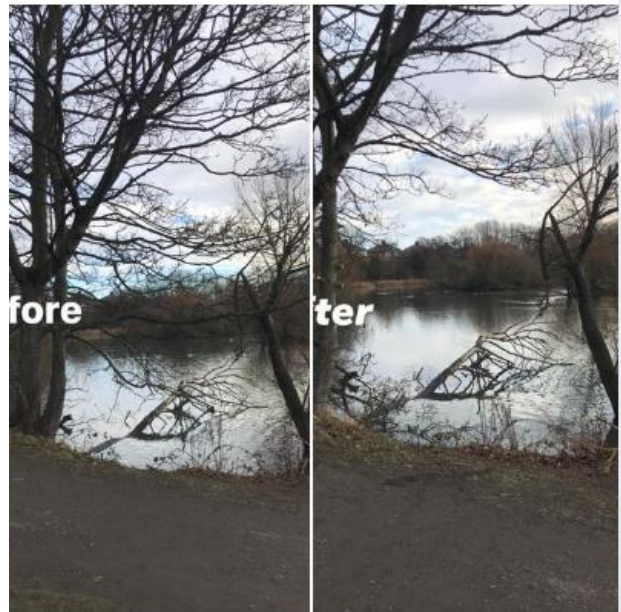
Some more work today in the Quarry cutting down low level branches creating more light. Also creating lovely view points in the process
