Water Environment Improvements Project Evidence Form

Milkwellburn Wood

Funding from the NWG Bluespaces scheme has enabled Durham Wildlife Trust and partners to achieve 3.8 km of improvements to water environments within Milkwellburn Wood Nature Reserve, near Blackhall Mill, Gateshead.

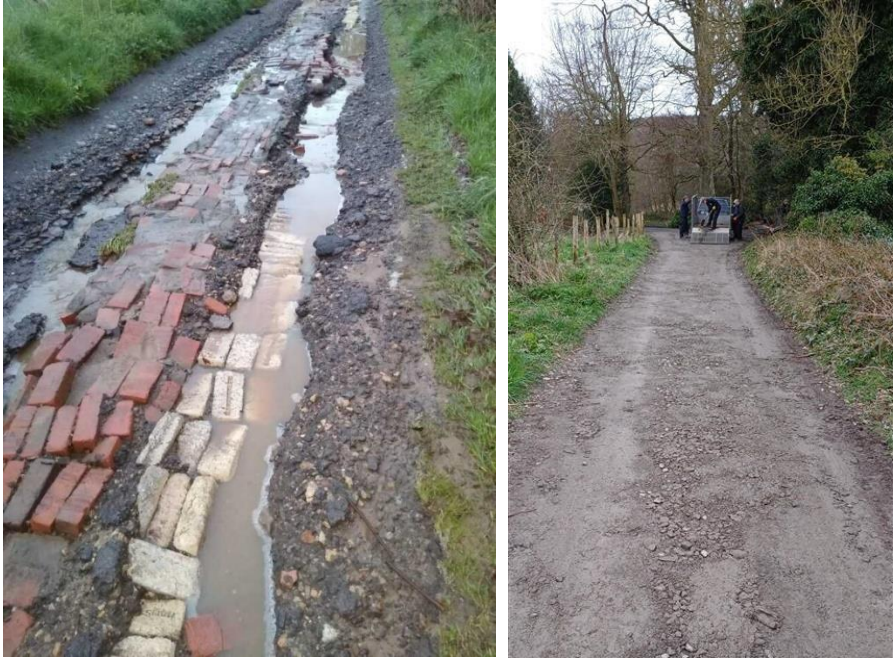
<p>Entrance track before repairs, impacted by flood damage, and improved surface during volunteer repairs</p>

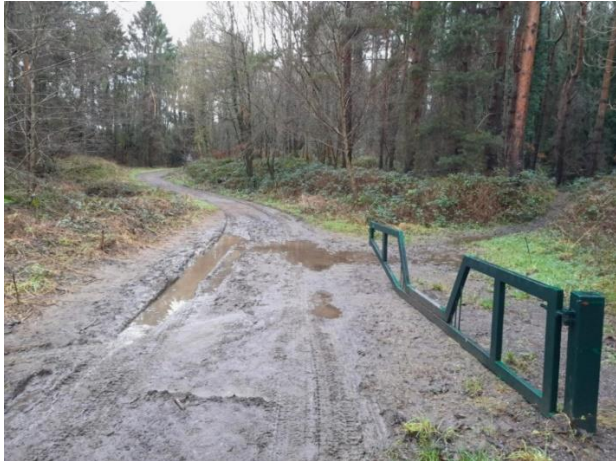
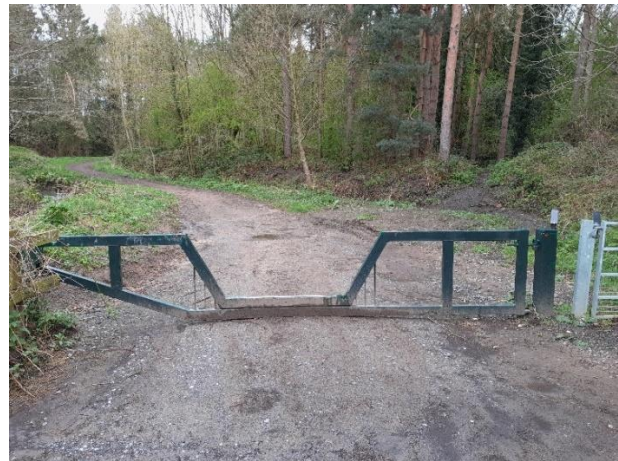
Before and after images of the entrance path surface improvements (after photo taken after heavy rainfall)

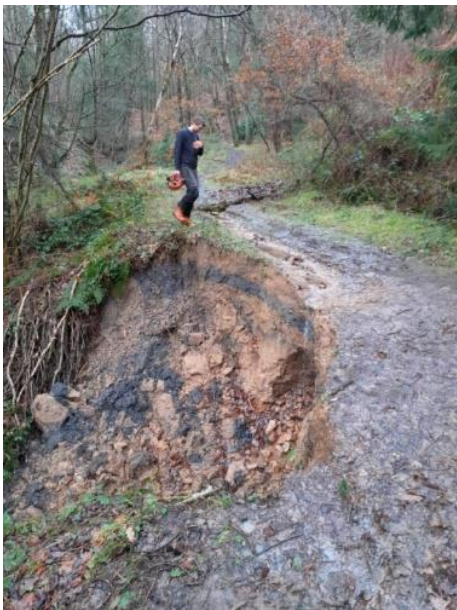
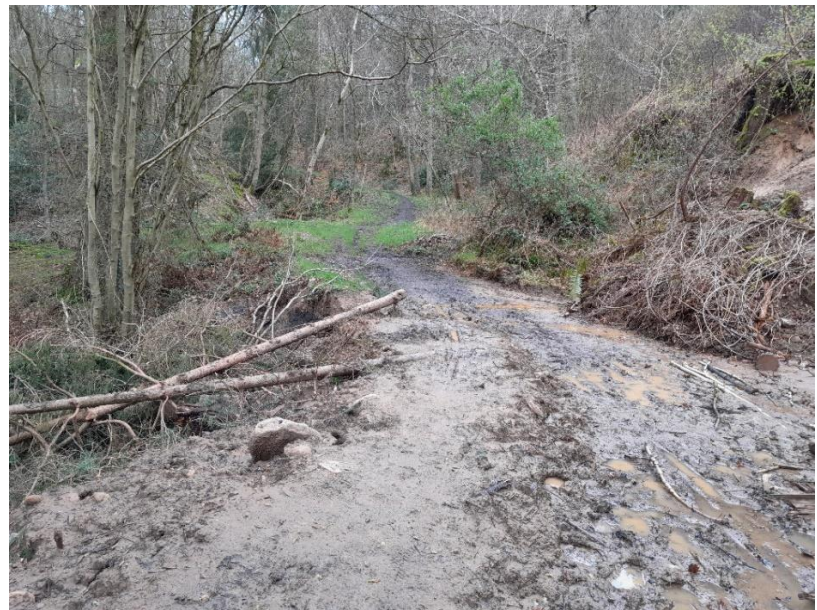
Before and after erosion repairs by a contractor and culvert repairs by volunteers (surfacing to be completed soon)

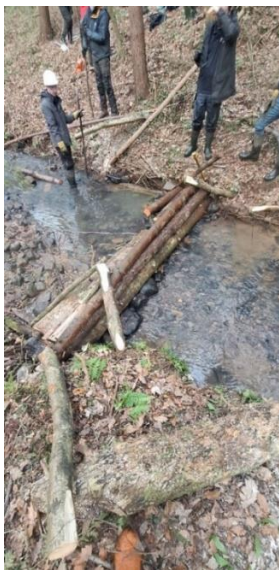
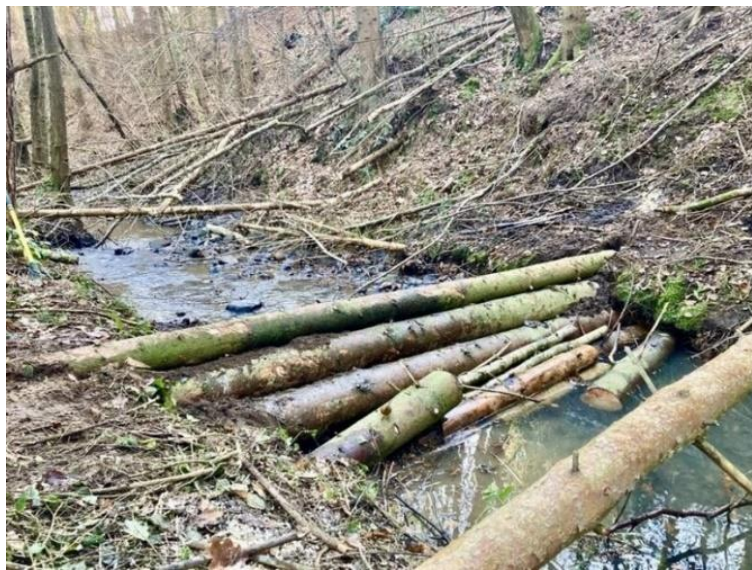
Woody dam construction

1. In total 13 run off attenuation features (woody dams) have been installed by volunteers using natural material on site, creating microhabitats for invertebrates and other wildlife. A culvert overflow bypass channel was also created by contractors in 2023. Willow weaving was also used across the site as a natural solution to protect banks from erosion. The success of the woody dams means further features will be incorporated into future site management activities.

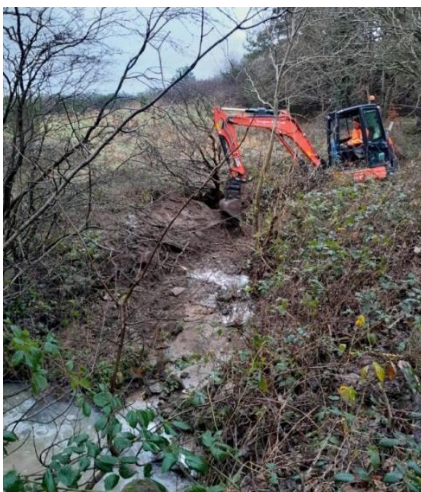
Overflow channel construction

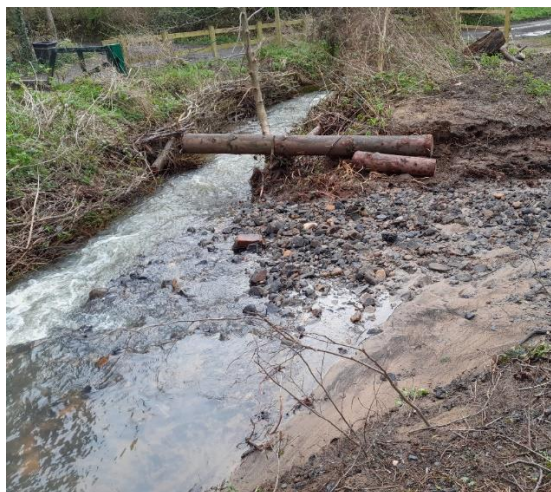
Overflow channel after heavy rain

“My husband never believed this overflow channel would work, but we had a huge amount of rain yesterday and it did! We’ve experienced some awful floods in the village, so it’s really nice to see this kind of work being done”

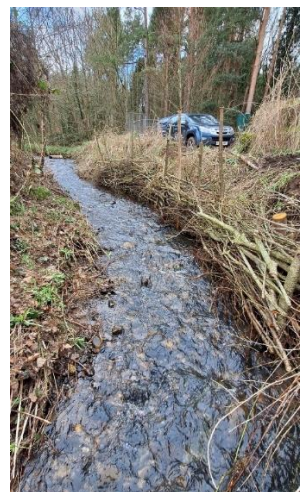
Willow barrier to prevent erosion

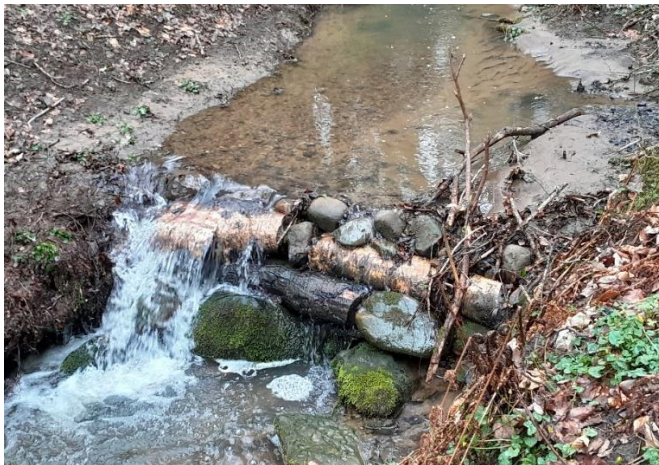
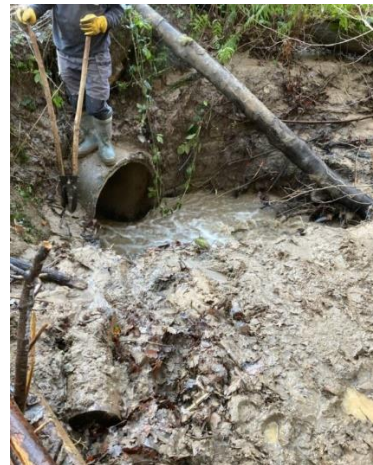
Woody dam with rapid sediment build-up from high flows, and a culvert being unblocked by volunteers

1. New features have already made an impact in slowing the flow and sedimentation has developed quickly behind some of the dams as a result. The culvert has not been breached since the project began, even after an extended wet period, and the dams are trapping sediments and reducing diffuse pollution reaching the River Derwent further downstream,.
2. As part of the project, culverts have all been cleared by volunteers and dams installed upstream where blockages are particularly likely, and a volunteer ranger is now instated to monitor culverts on-site to prevent and act on blockages quickly. There have been no issues with blocked infrastructure since the project began.

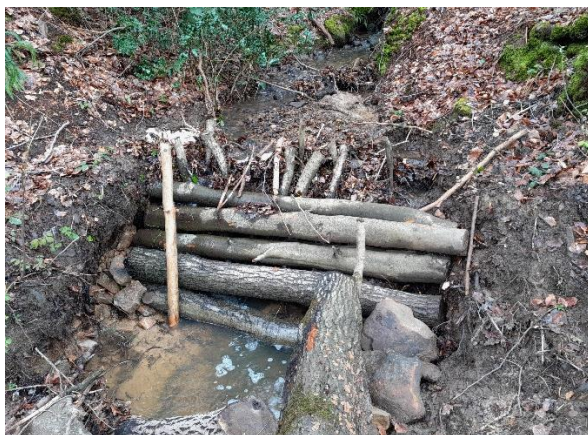
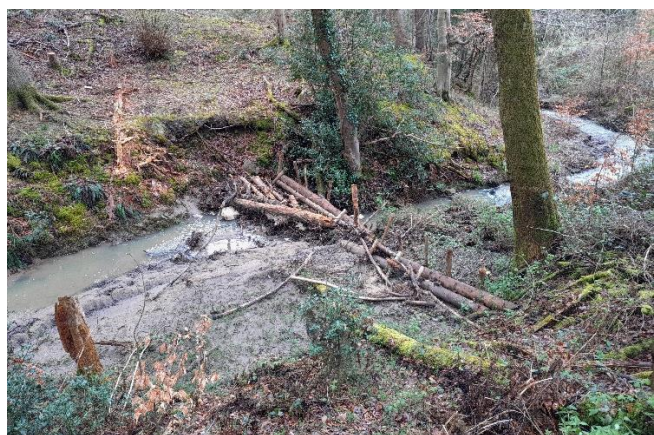
Woody dams installed upstream of culverts to protect them from debris
